Danish Clean Water

## COOLING TOWER INSTALLATION

**The Installation:** Evaporators of ca. 50 m<sup>3</sup> of water with 280 m<sup>3</sup>/h flow used for cooling in a range of processes within an industrial area.

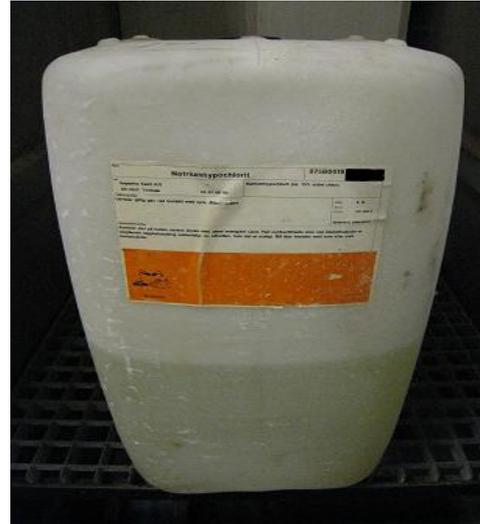
The original treatment protocols consisted of shock dosing manually with ca. 15% sodium hypochlorite. The shock dosage was an attempt to kill all bacteria as well to remove the biofilm. This proved ineffective and also provoked a high potential enhancing corrosion. The picture on the left was the data log used. No control was made whatsoever between dosages. Tests made in accredited lab showed fluctuating bacterial counts as well

F01 Kildevandsanlæg							
Dato	Spandevand OK/Red	Kølevand OK/Red	Store filter	Lille Filter	Salt	Chlor	Initialer
22/8	ok	ok	22/8	22/8			JH
24/8	ok	ok					HH
27/8	ok	ok			1000kg		HW
29/8	ok	ok				1 L	HW
30/8	ok	ok					JJ
31/8	ok	ok					JJ
1/9	ok	ok					JH
10/9	OK	OK					HW
12/9	OK	OK	12/9			1	
13/9	ok	ok					JJ
17/9	ok	ok					JJ
19/9	ok	ok	19/9	19/9	1000kg	2	JH
23/9	ok	ok					JH
24/9	ok	ok					JH
25/9	ok	ok					JH
29/9	ok	ok				1	JH
1/10	ok	ok					JH
3/10	ok	ok					JH
2/10	ok	ok			1000kg		JH
4/10	OK	OK	4/10				JH

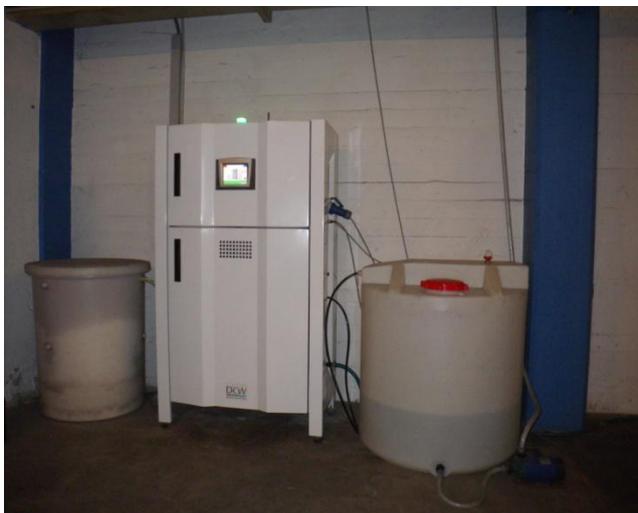
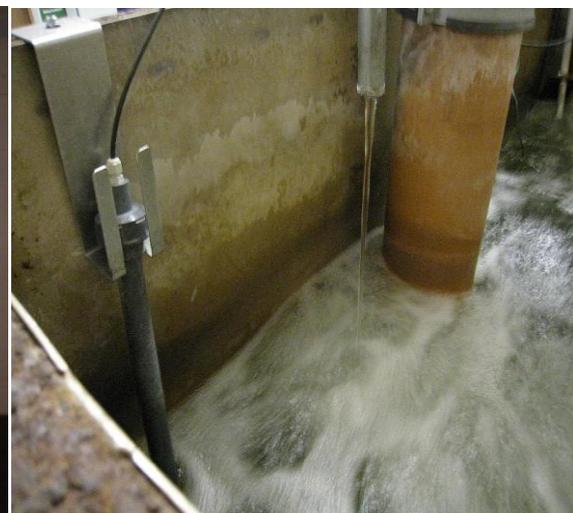
A 40 liter generator of Neuthox was employed to solve the problem. The installation included the salt and buffer tank with a dosing pump controlled by an ORP (REDOX) sensor. The dosing pump was set to dose

when the ORP dropped below 535 mv . This has resulted in an average free chlorine level of 0.5 ppm. The dosing pump was selected for its ability to transfer the Neuthox some 30 meters from the buffer tank to the open tank as it was not possible to locate the generator within the plant room due to size constraints. The ORP sensor was located in the open tank near the incoming water and the dosing point located near the water outflow to avoid any false readings.

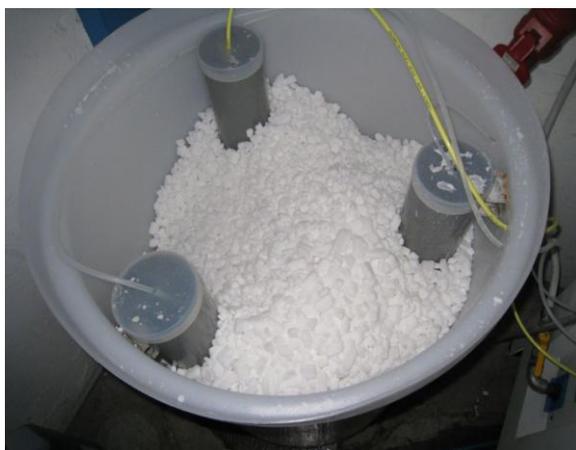
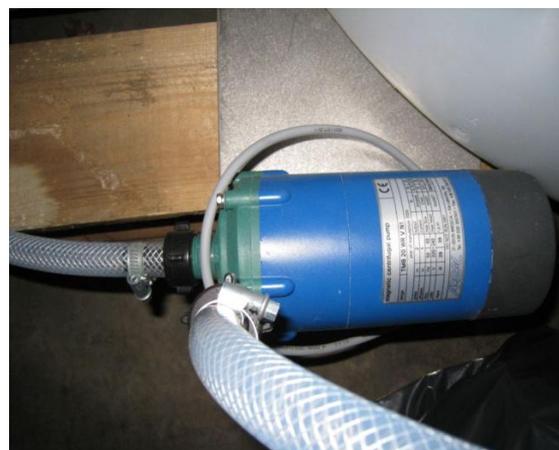
The pictures down show a detail of the salt tank (left) and the dosing pump (right).

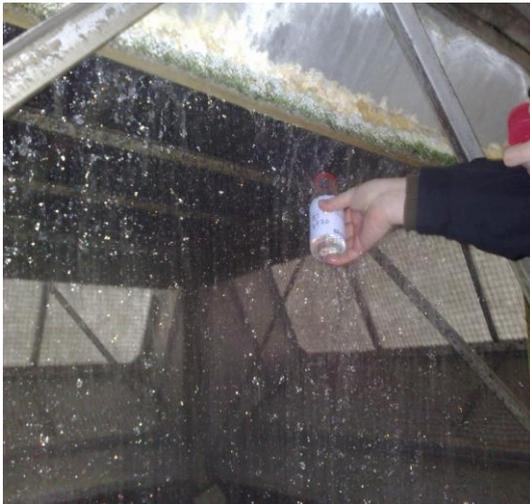
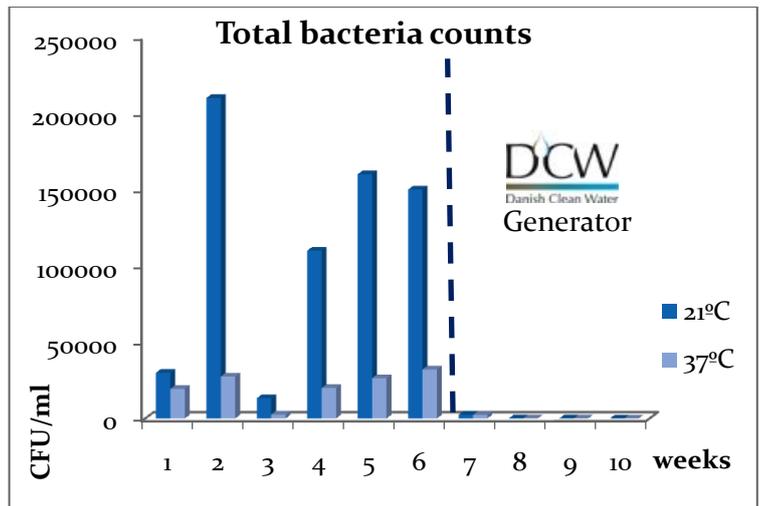
Tests were made every week in accredited lab before and after the installation. The results clearly show bacteria counts inferior to log 2 since week 7 when the generator was installed. On site it was also observed that the biofilm present in the system was reducing. Pseudomonas was no longer detectable.
